Global Property Inspections

Joe Client, 3136 Any St., City, Prov. PC

Inspection Date : 10/4/2006
Inspector: John Anyman
Inspector Phone:555-555-5555

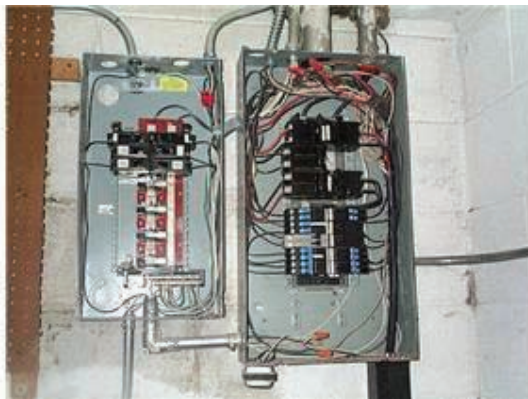
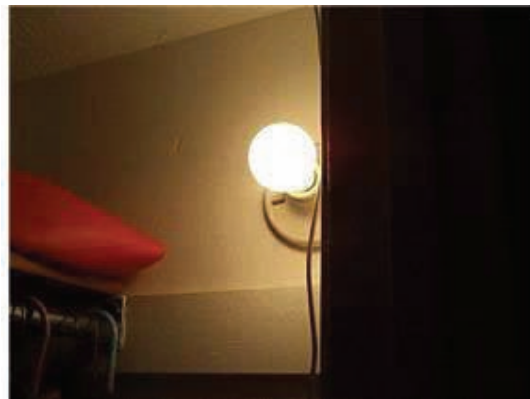
Undersized wires noted at breakers in service panel. Open knock-outs present in panel. Neutral and ground wires are connected on the same bus bar in sub -panel. Under-sized wire feeding sub-panel from service disconnect in main panel. Scorching observed in sub-panel. Missing globe protector on light in basement closet. Open grounded outlet in master bedroom. Recommend further evaluation and repair by a licensed electrician.
