GLOBAL
PROPERTY
INSPECTIONS™

TOP 10 RED FLAGS

Understand what issues your homebuyers are on the lookout for and how to offer solutions.

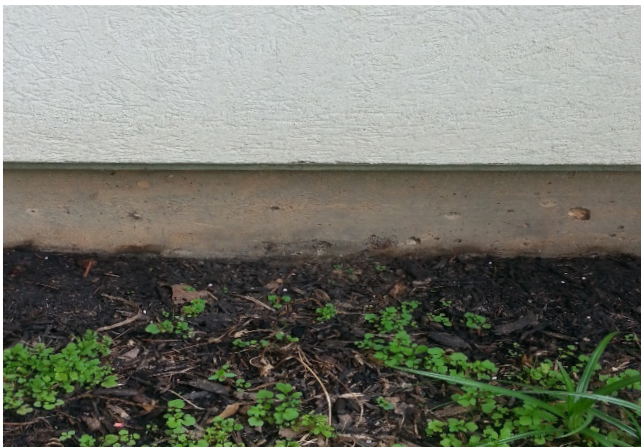
Right.

High grading around the foundation is one of the most common issues identified on inspection reports. The proper minimum clearance between the facade and the soil is 4 to 6 inches. High grades are most commonly found in planter areas. Homeowners often place new mulch without removing the old, creating potential issues.

Drainage problems are avoidable with proper grading. Site grading should always slope away from the foundation for at least 5 feet. Gutter downspouts should always direct the water at least 5 feet away from the foundation or deposit into a site drainage system.

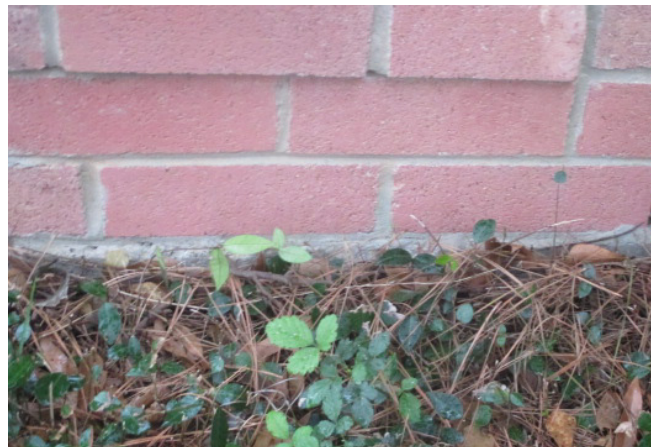
Wrong.

Ponding water around a foundation can cause a loss of support and settlement. When water sits against the foundation without proper drainage, the ponding can result in wood rot and mold throughout the structure.

Siding, stucco and stone/brick veneers are not waterproof, so water easily penetrates the exterior walls. High grading can obstruct the weep holes that allow the moisture to escape. If the drainage is blocked, the moisture gets trapped in the wall, promoting more wood rot and mold.

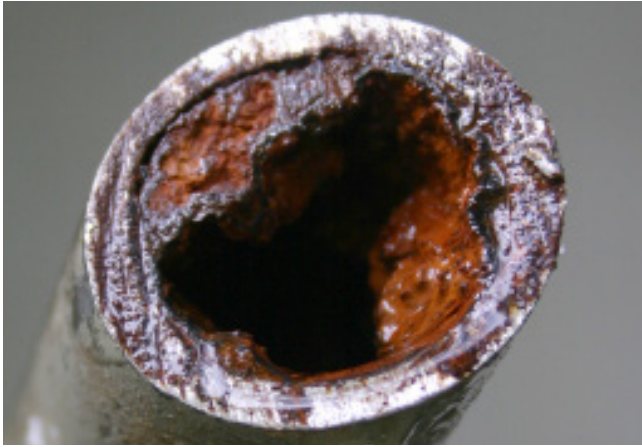
#9 - GALVANIZED PIPES

“Galvanized” pipes are zinc-coated pipes that were meant to prevent rusting. Galvanized piping was common until the 1950s and lasts around 40 to 60 years.

When galvanized pipes are found today, they are usually near the end of their lives and in need of replacement.

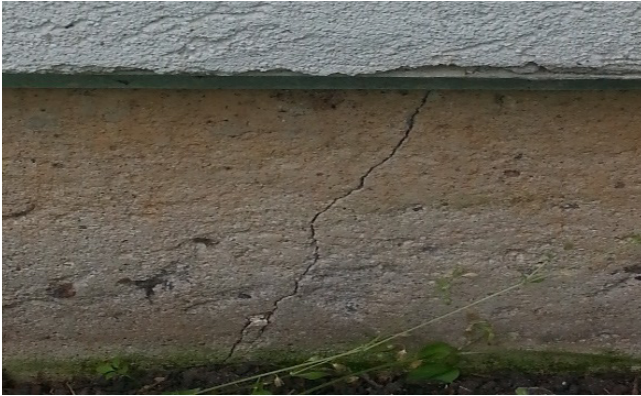
Hairline Cracks (1/16 inches or Less)

Hairline cracks are most likely caused by shrinkage during the curing process of poured concrete. They do not present any concern.

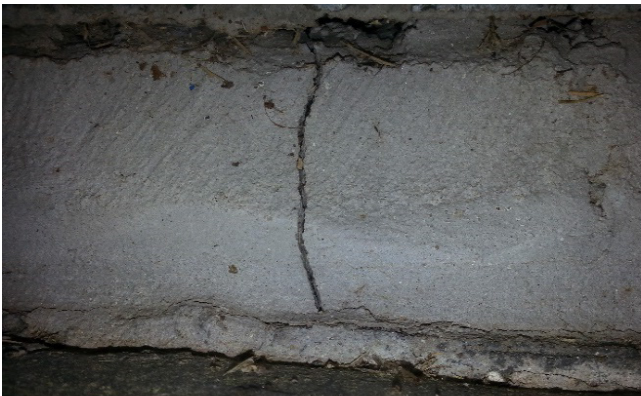
Cracks 1/8 inches or Less

Cracks this size may indicate either shrinkage from curing or foundational movement. This crack should be sealed and monitored.

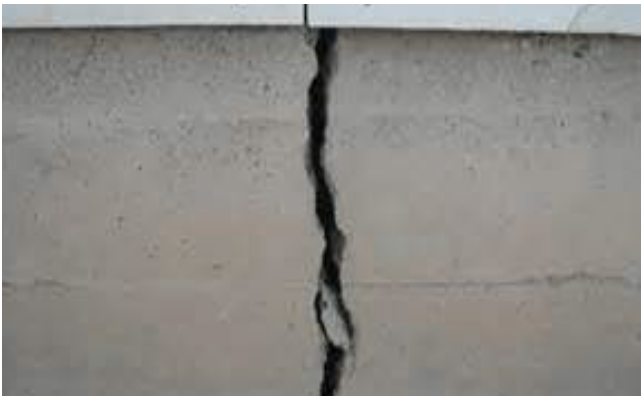
Cracks 1/4 inches or More

Cracks this large are most likely due to foundational movement. A structural engineer should be consulted.

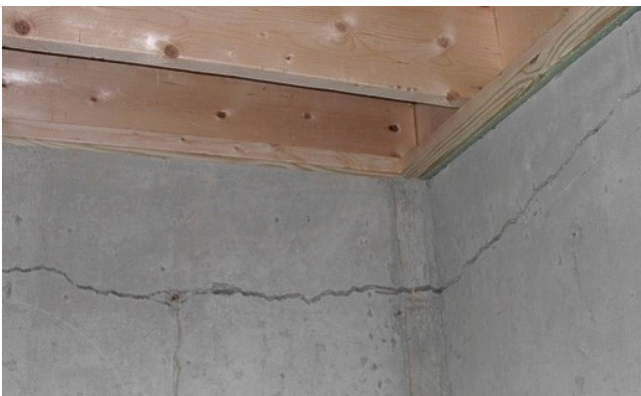
Basement Foundation Walls

Horizontal cracks found in the basement can be minor or major. Some minor cracks may be repairable DIY-style. Depending on their width and severity, some cracks may require stabilization repairs such as wall tiebacks or carbon fiber reinforcement. An NPI inspector would typically suggest a consultation with a structural engineer.

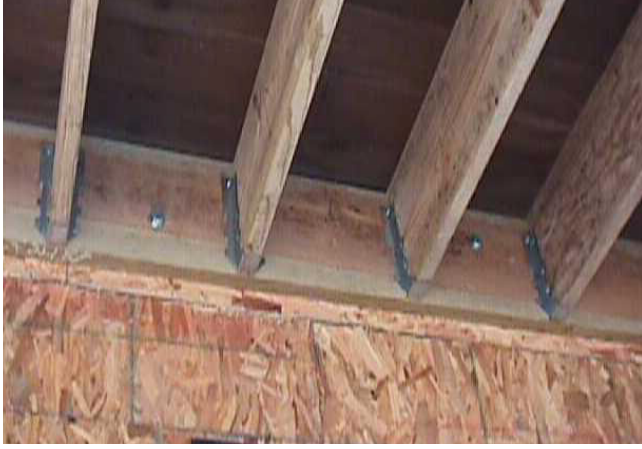
#4 - POOR DECK CONDITIONS

Poor deck conditions are often visible to untrained eyes. Check for post deterioration or chipped paint. Less obvious red flags exist in a deck's support system. Unstable support is often characterized by uneven or sloped boards.

Industry standards require all ledger boards be bolted to the house, and joist hangers must be installed on every joist with the appropriate type and amount of fasteners (left). All decks should have adequate fall protection including handrails and spindles.

Most deck issues can be self-repaired by a homeowner. For any structural concerns, a homebuyer can request an engineer consultation. Deterioration can be prevented with adequate maintenance and updated sealant.

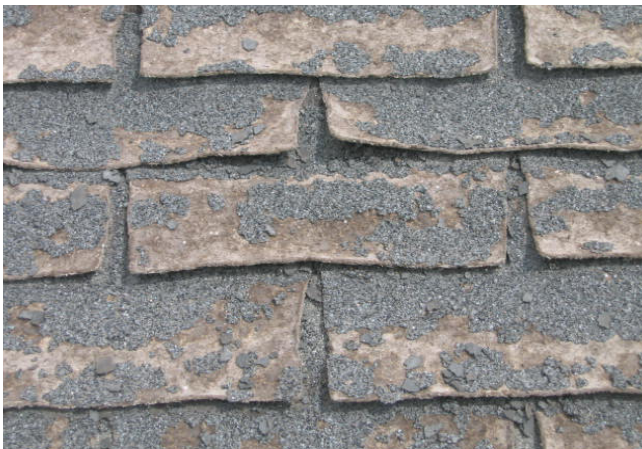
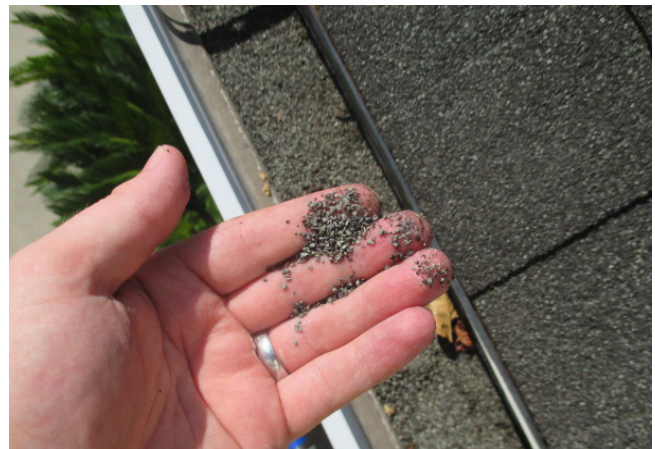
Roof condition is often a key factor in home appraisal. Excessive granular loss (pictured above) is a key indicator of poor condition. Note that the south-facing side of a house always displays the most wear.

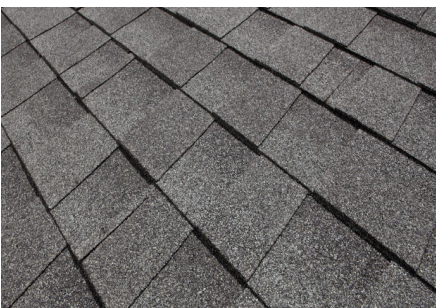
New, 0-5 years

Little to no granular loss
No cupping or curling
Straight edges

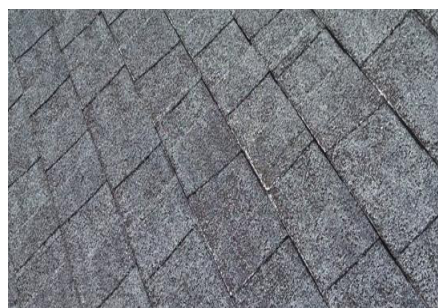
Medium Wear, 5-15 years

Mild to moderate granular loss
Some cupping or curling

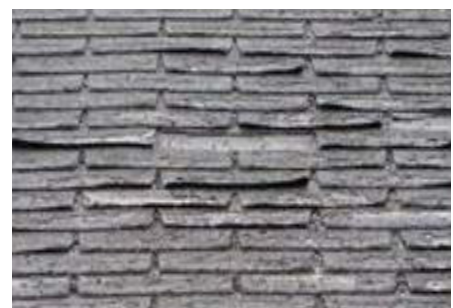
Heavy Wear, 15+ years

Excessive granular loss
Excessive cupping or curling
Deformed edges

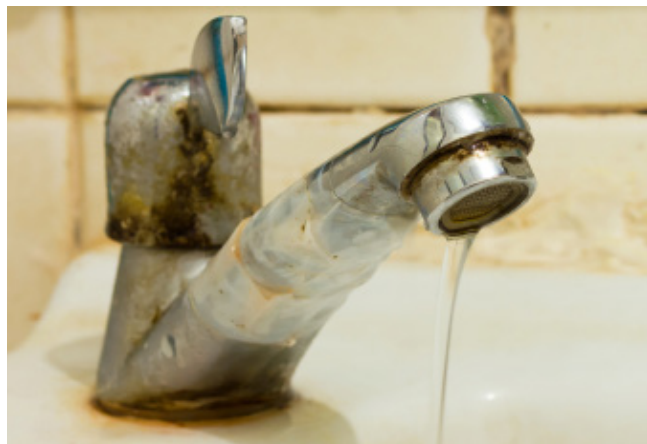
Small amounts of mold and mildew around showers, tubs and sinks are normal (above, left). Small amounts of mold on window sills are normal and most likely caused by condensation. These do NOT present a major problem or concern.

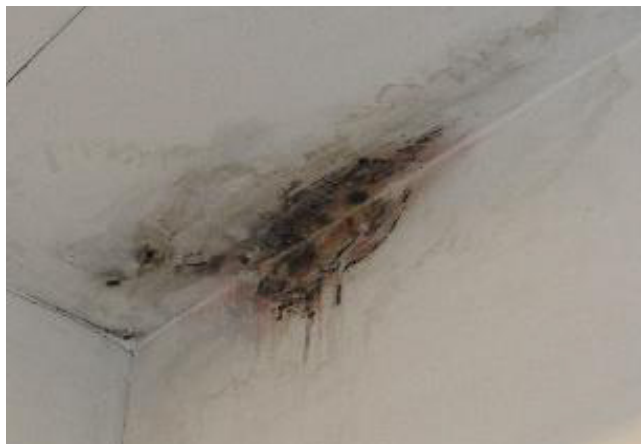
However, mold found on walls or ceilings outside of a kitchen or bathroom DOES signal a problem (above, right). Typically, this indicates a roof or plumbing leak. Any amount of mold to the sides or below a window or door indicates a leak as well. These are definitely a major problem.

If you suspect a home has mold, encourage the owners to schedule a mold inspection immediately. Locating mold as soon as possible is key to saving thousands of dollars.
